Final Report

CALFED Water Use Efficiency Program

Yolo County Resource Conservation District Pilot Program 2001

May 2002

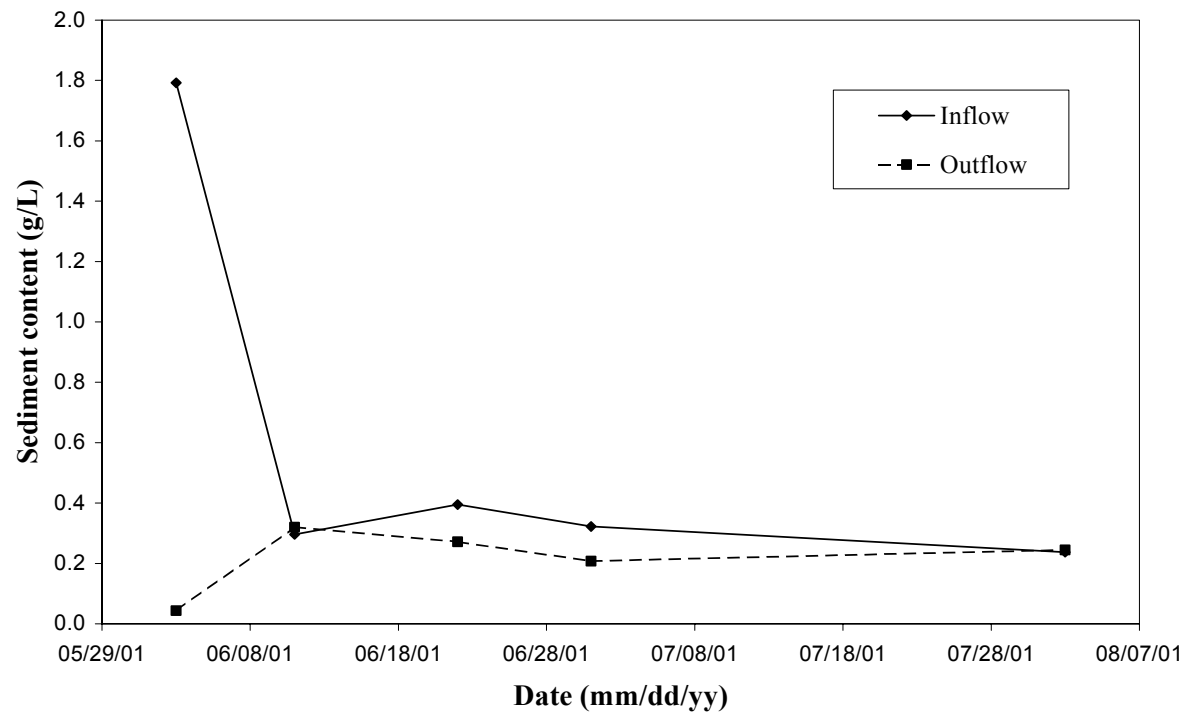
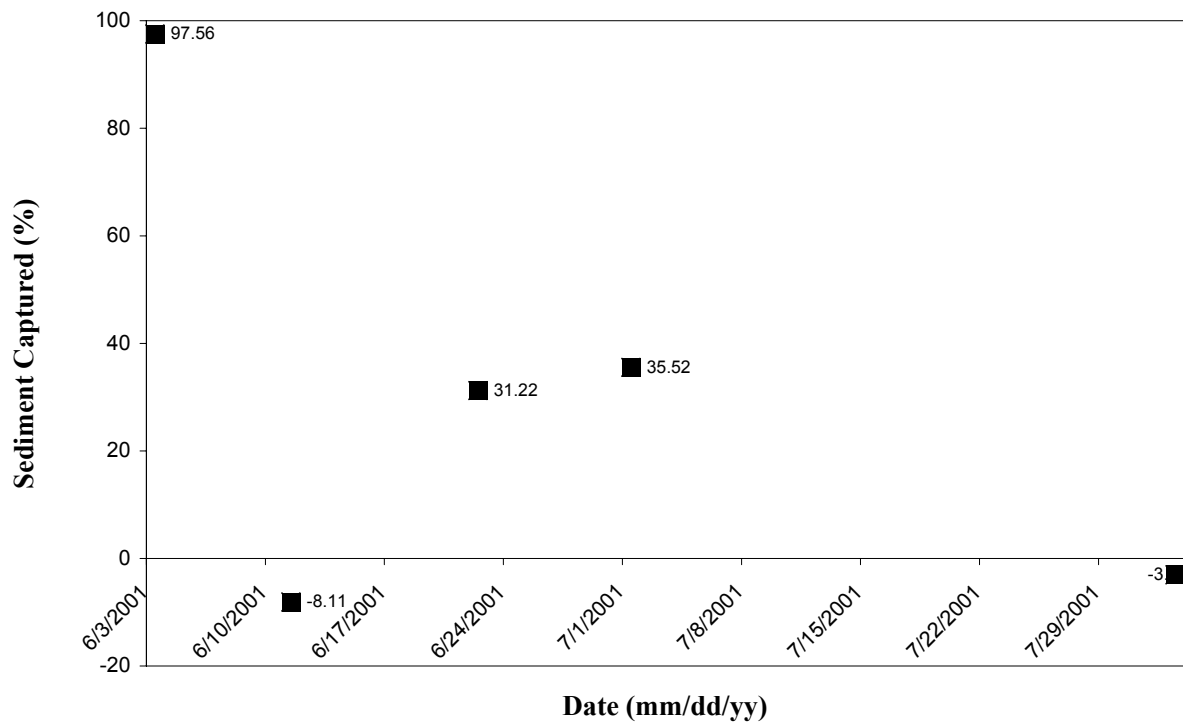
Figure 29: Sediment content in samples collected from the SMCC trap.

Figure 30: Percent of sediment captured at the SMCC trap.

The sediment content in inflow and outflow samples for this trap is shown in Figure 29. As with trap SM65, inflow sediment content decreased through the season, indicating that more erosion occurs during the first irrigations. Figure 29 also shows that the sediment content in the outflow samples was, at one point, higher than the inflow samples, corresponding to when the trap was full of sediment. In this case, cleaning out the trap before the end of the seasons was not an option for the farmer. To increase the capacity of this trap an additional board was placed in the flashboard riser, which allowed additional water to pond. The curve in Figure 29 illustrates the resulting drop in outflow sediment concentration relative to inflow sediment concentration. However, by the end of the season the trap was full again and the inflow and outflow sediment content were nearly the same. This result can also be seen in Figure 30, which shows the change in the percentage reduction throughout the season. This figure also shows that increasing the volume of the trap by adding a board to the riser increased the percentage of sediment captured and kept it elevated for the rest of the season.

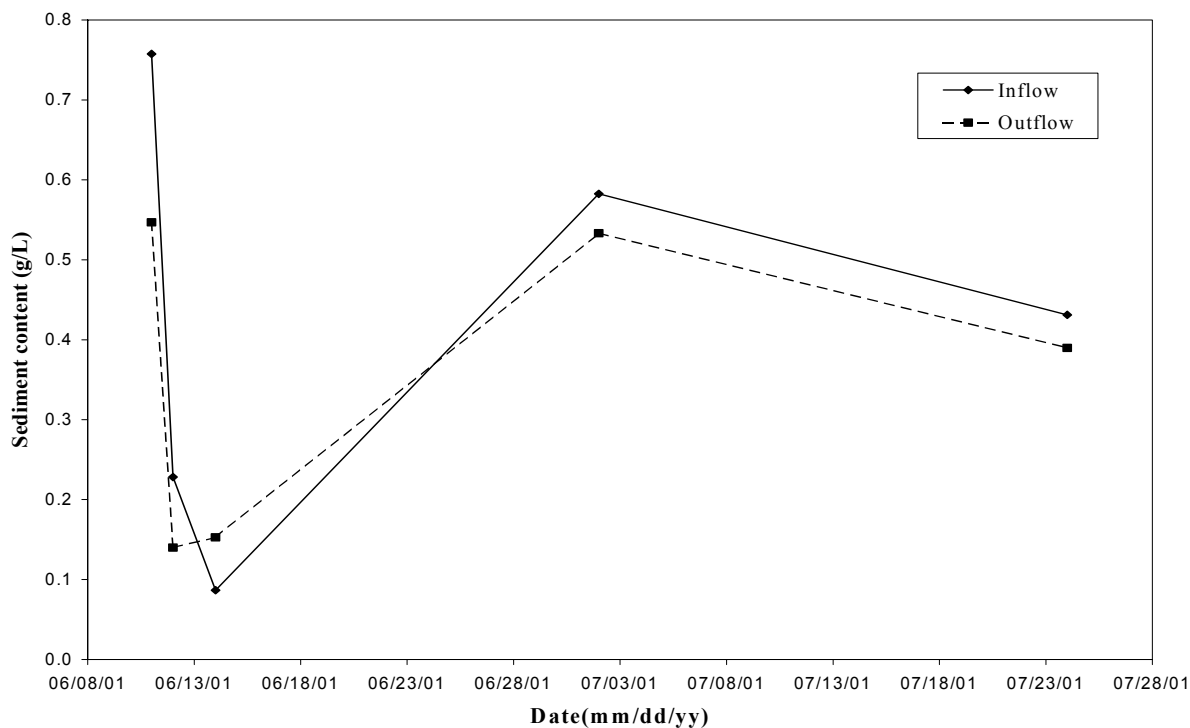
Figure 31: Sediment content in samples collected from the SB64 sediment trap.

As mentioned earlier, this trap was successful in terms of collecting sediment. District personnel were also able to collect inflow samples throughout the season. Figure 31 indicates that the SB64 trap was successful in reducing sediment content in the outflow most of the time. Figure 31 also shows that there was one event when the sediment content in the outflow sample was higher than the sediment content in the inflow sample. This might have been due to water ponding problems downstream of the trap. Most of the time, outflow from the sediment trap was immediately mixed with stream backflow, which might have caused error in outflow sediment measurement results.

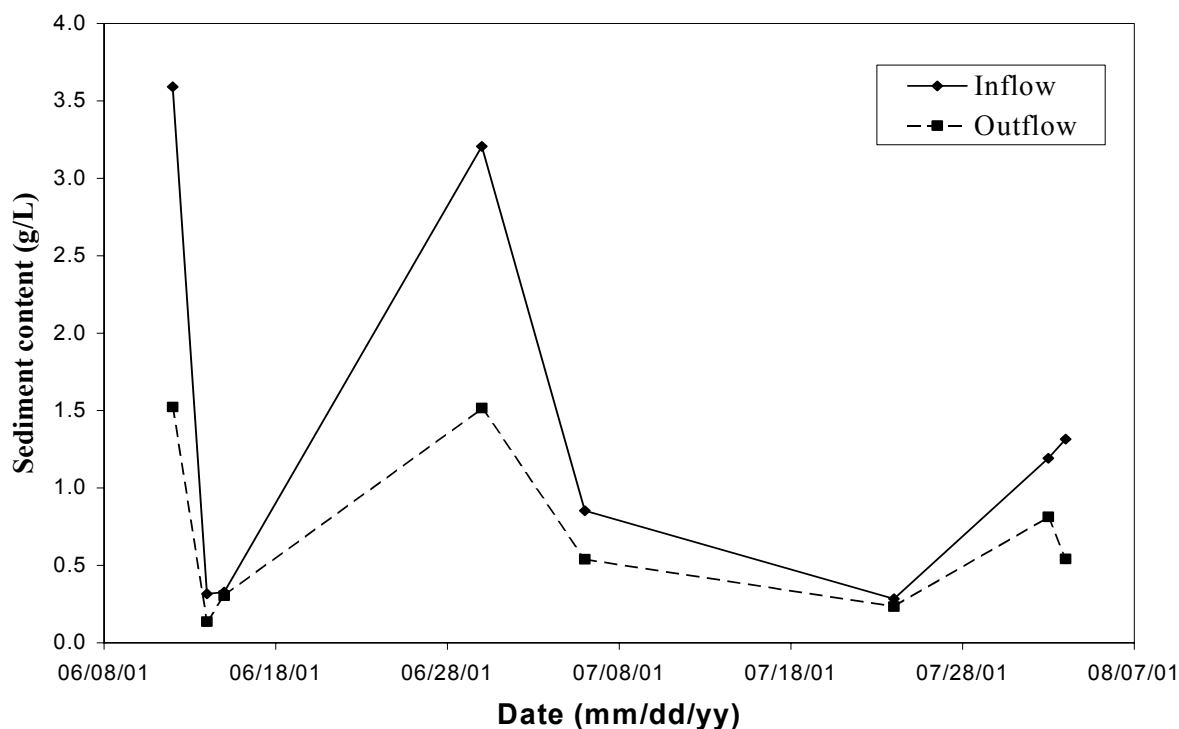
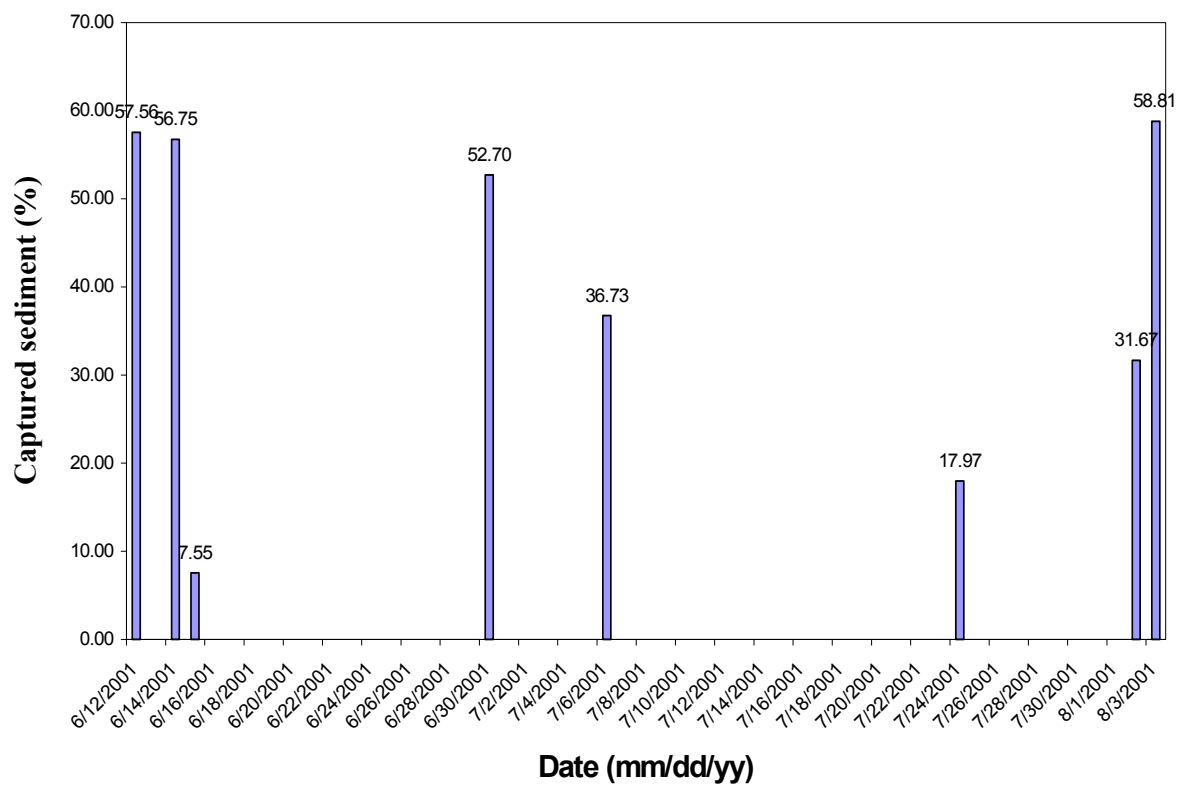
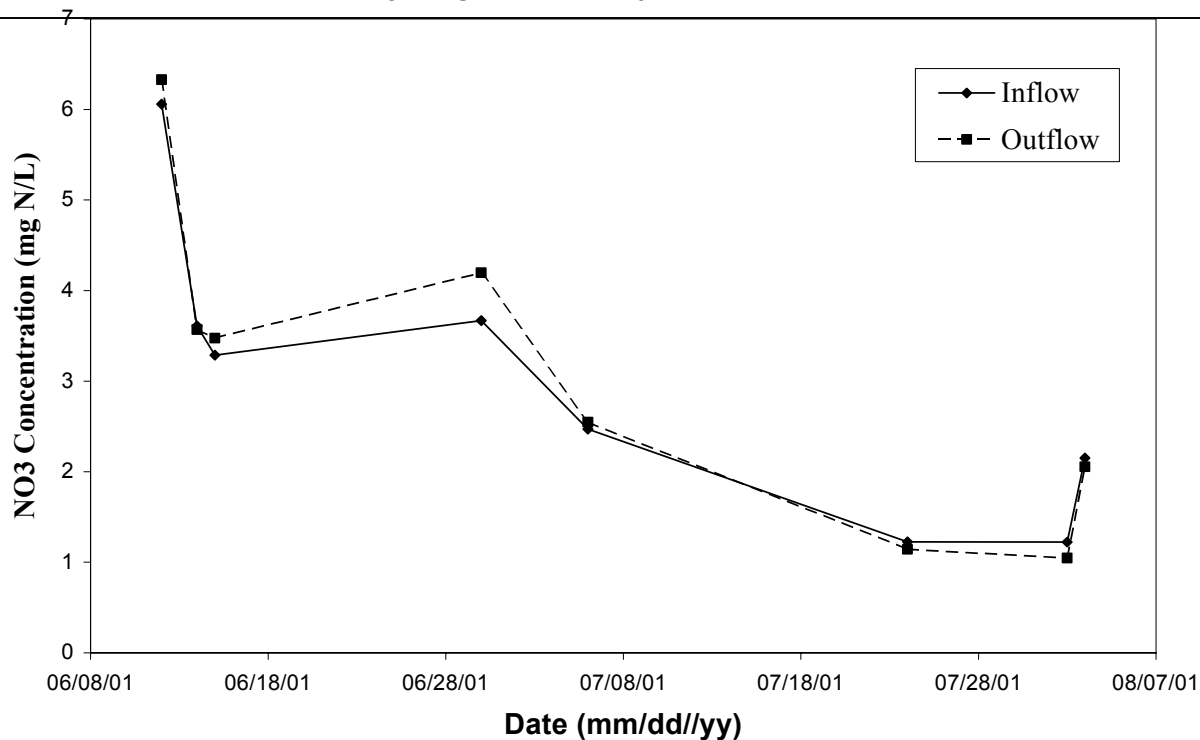
Figure 32: Sediment content in samples collected from the SBTC sediment trap.

Figure 33: Sediment capture efficiency at the SBTC trap site.

Figure 34: NO3 Nitrogen concentration in samples collected from the SBTC sediment trap.

Figure 32 shows that this sediment trap was successful in reducing the sediment content in runoff throughout the entire season. Although the percentages of reduction varied, it remained positive. While inflow sediment content in most of the other sediment traps continued to decrease throughout the season, it (solid line in Figure 32) shows a different pattern in the SBTC trap. This is likely because this trap received runoff from two fields, hence two drain ditches instead of one. The presence of two source fields explains the second peak in the inflow curve, which represents the first time runoff was received from the second drain ditch. Figure 33 shows the changes in percent sediment capture throughout the season. Figure 34 is another example of how NO_3 Nitrogen concentration in both inflow and outflow samples decreased gradually but not consistently throughout the season.

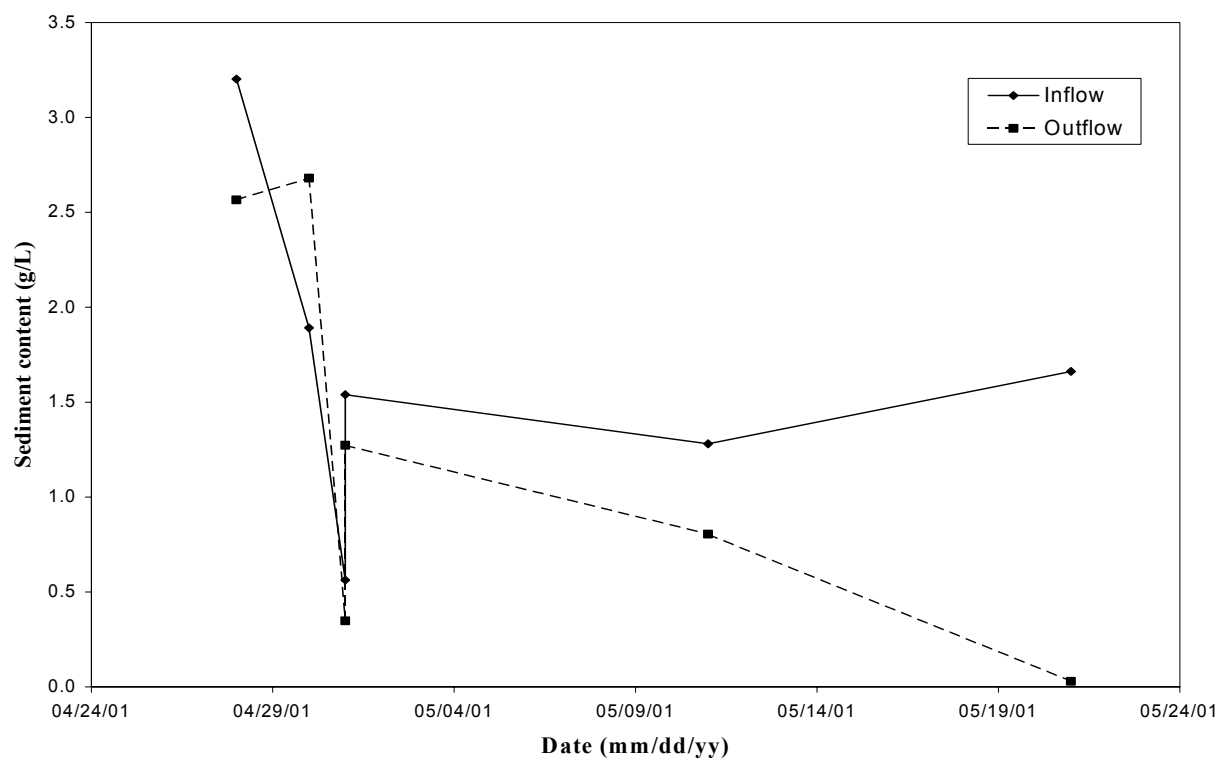
Figure 35: Sediment content in samples collected from the SB17 sediment trap.

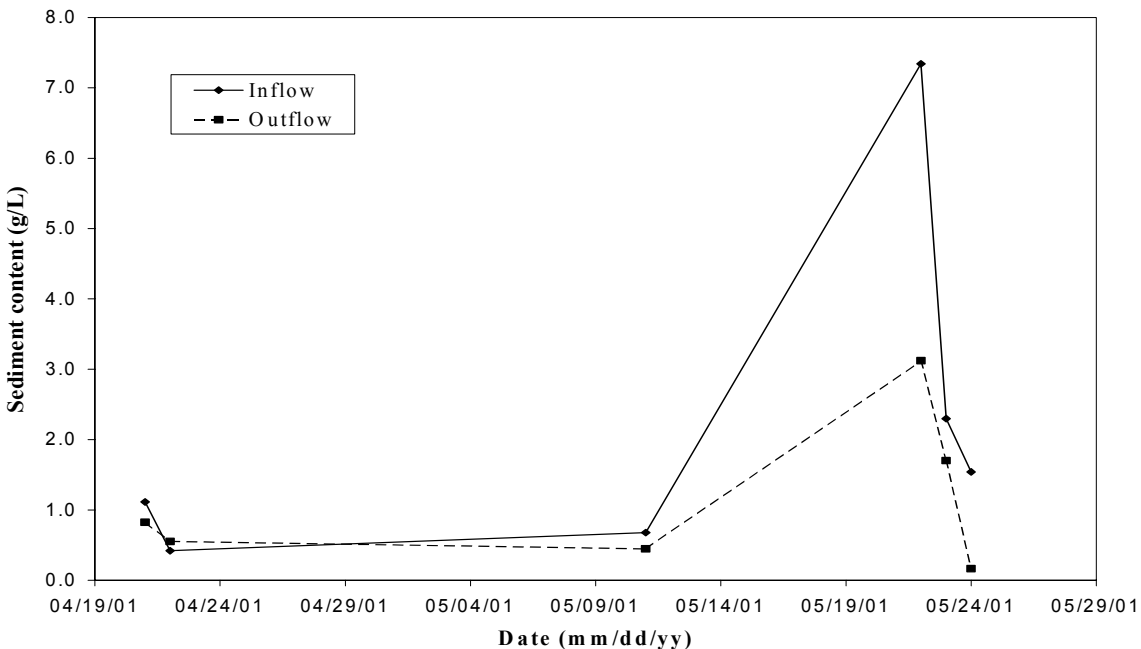
Figure 36: Sediment content in samples collected from the SRCH sediment trap.

This trap filled with sediment early in the season, after which we ceased sampling. Results from samples collected are shown in Figure 36. The results show that the trap was working properly before it filled with sediment. Sediment content in outflow samples was lower than that for inflow samples except for the second sample point, at which the difference in values is very small (0.02 g/L).

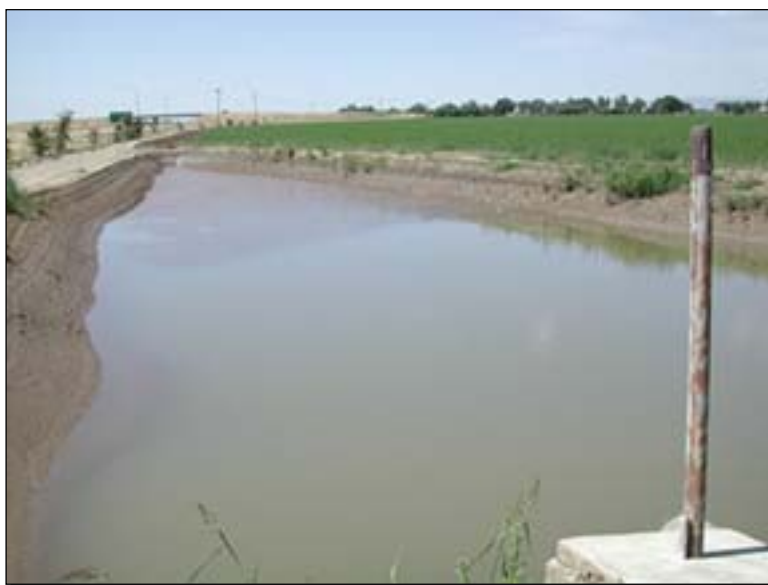
Figure 37: View south across Tail water pond PBHR

This pond collects runoff water from a 43-acre tomato field and a 63.7-acre corn field (Figure 37). There are two inlet drop structures at this pond. Water collected in the pond is recycled to irrigate the tomato field using a pump and a gated pipe irrigation system. This pond has steep sides and is deeper than most other ponds in this study. The top of the west bank of this pond is planted with Creeping wildrye. This pond was constructed three years ago (fall 1998) with a total capacity of 1910 yd³ (51570 ft³). It was cleaned out once in fall 1999 because of instability of the north bank of the pond (steep with sandy soil). No sediment trap is attached to this pond.

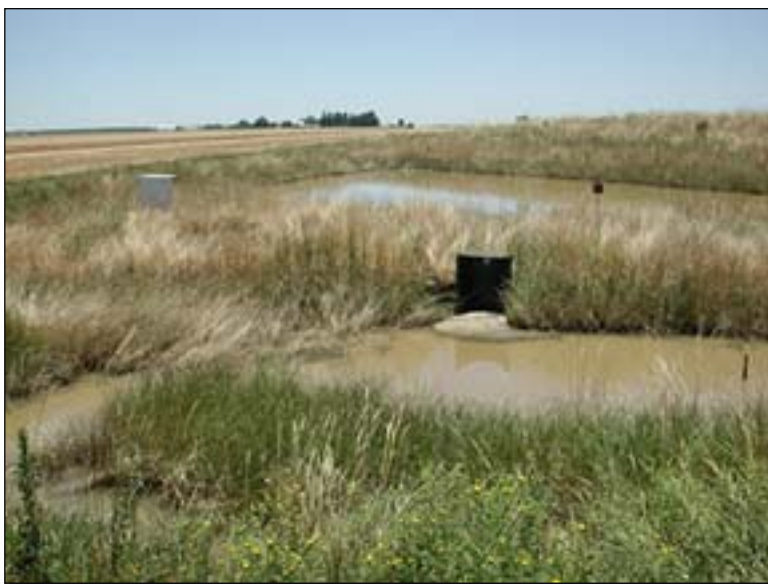
Figure 38: Tail water pond PROM

This pond (Figure 38) collects water from a 50-acre conservation-tillage corn field and a 20-acre native grass field (totaling 70 acres drained). It has a maximum capacity of 1,832 yd³. Attached to this pond is the SROM sediment trap (Task 3, Section 4). The inlet drop structure of this pond is the outlet drop structure for the SROM. The pond was constructed two years ago and has never been cleaned out. Water collected in the pond overflows into a ditch, which collects runoff water from other fields. This aggregated drain water is collected further downstream in a large pond from which it is pumped back to the top of the ranch for re-use on any field.

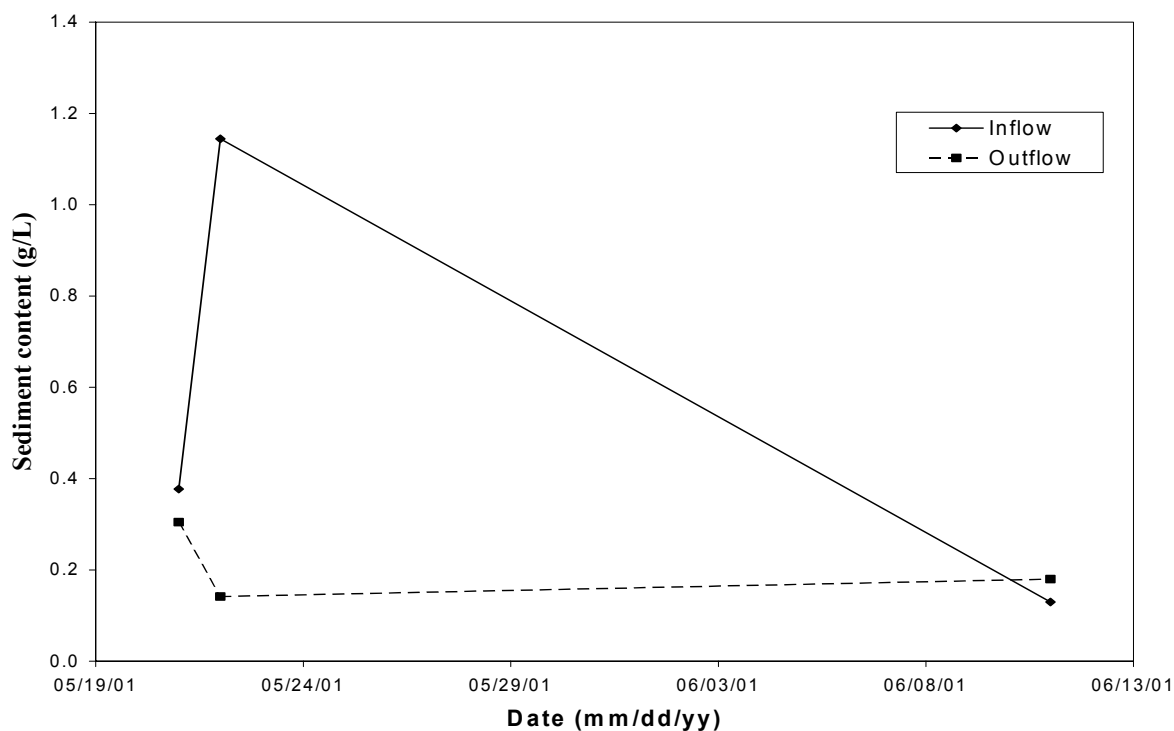
Figure 39: Sediment content in samples collected from the PMJ pond.

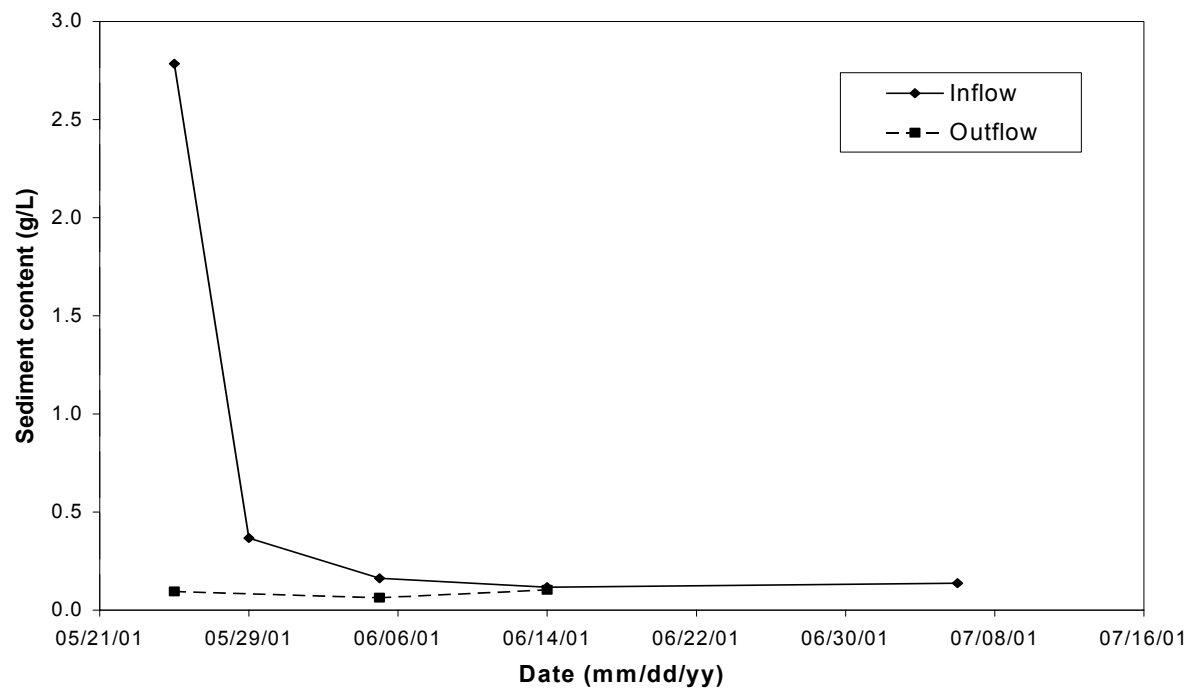
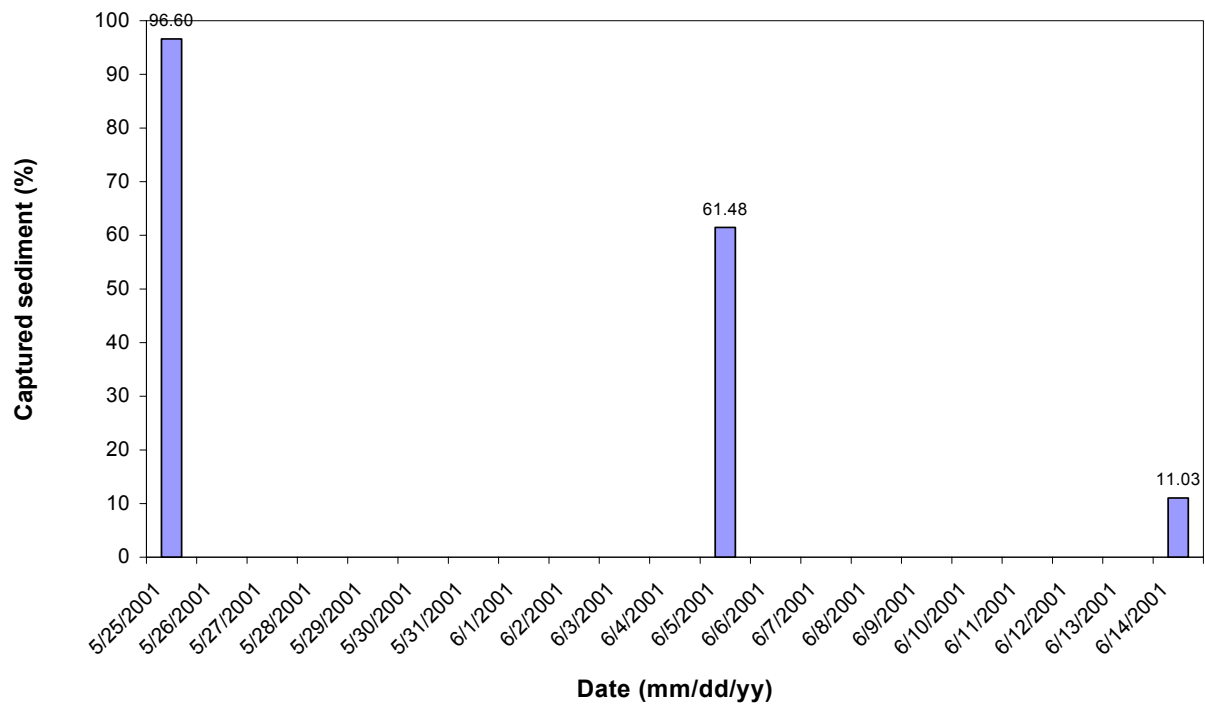
Figure 40: Sediment content in samples collected from the PBOR pond.

Figure 41: Percent sediment captured in the PBOR pond.

Figure 35 shows the results obtained from inflow and outflow samples collected from this pond. This figure indicates that sediment content in outflow samples was lower than that in inflow samples. In addition, the sediment concentration in the inflow samples was highest at the beginning of the season. Figure 36 shows the percentage of sediment that was captured in the pond throughout the irrigation season. However, the results obtained from the pond survey show a different result. It was estimated that approximately 40 yd³ left the pond during the irrigation season. Again, this suggests a problem in the survey technique.

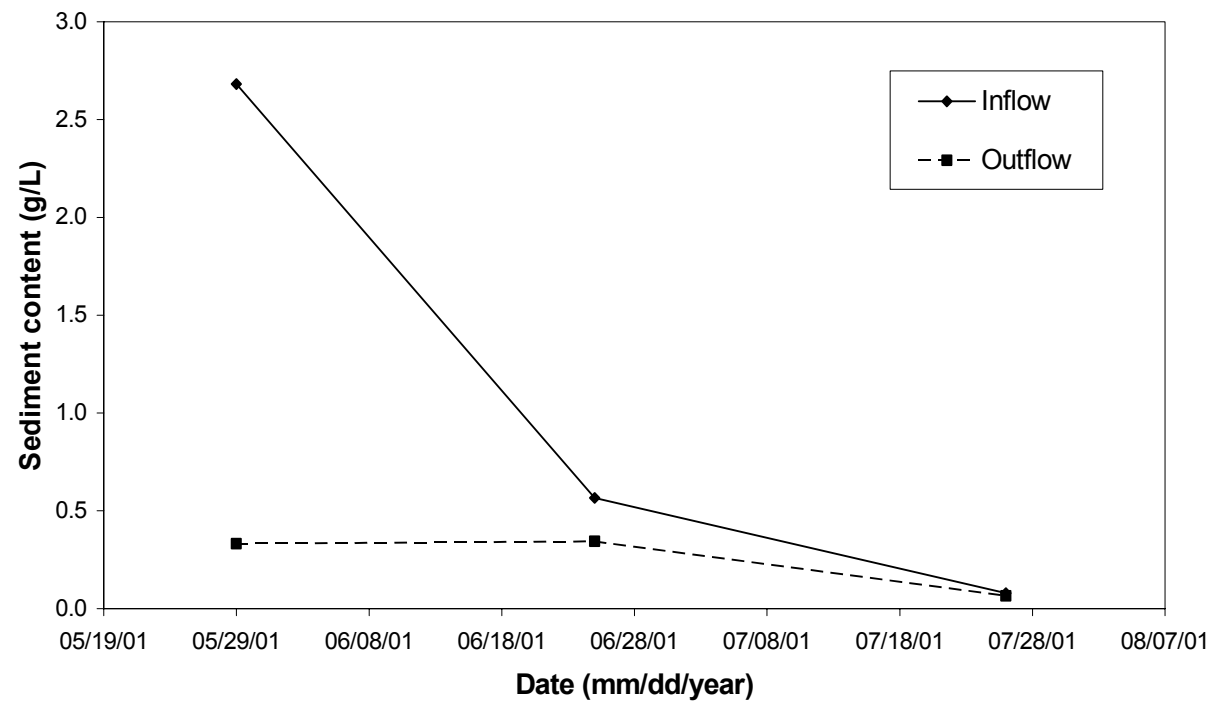
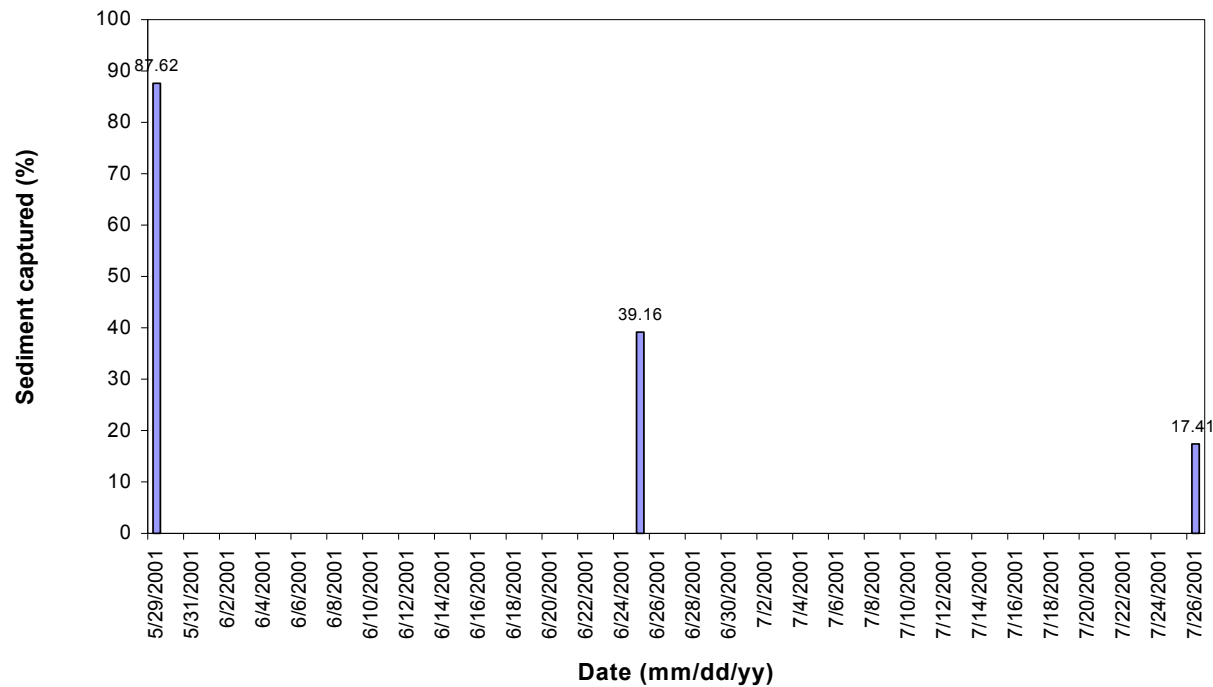
Figure 42: Sediment content in samples collected from the PROM Pond.

Figure 43: Percent sediment capture in the PROM Pond.

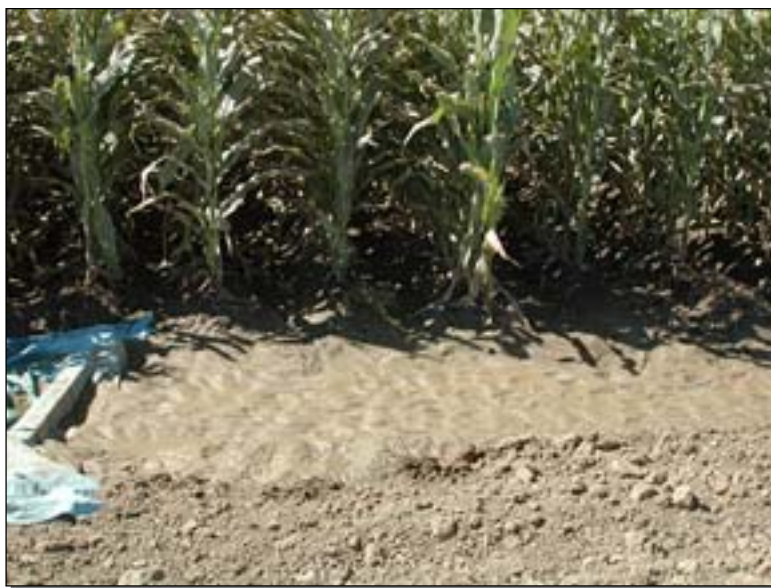
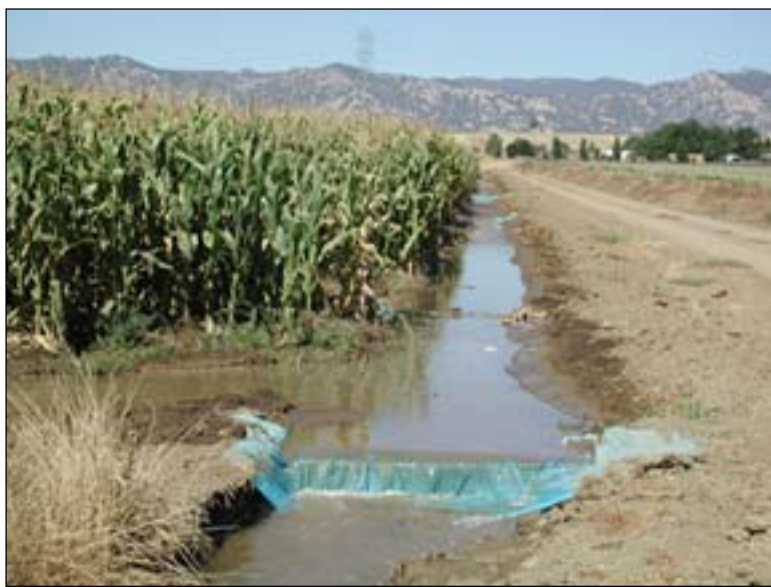
Figure 44: Canvas dams slow the tailwater and allow the collection of sediment before it reaches the sediment trap and/or pond

Figure 45: Tail ditch showing ponded water behind canvas dams.

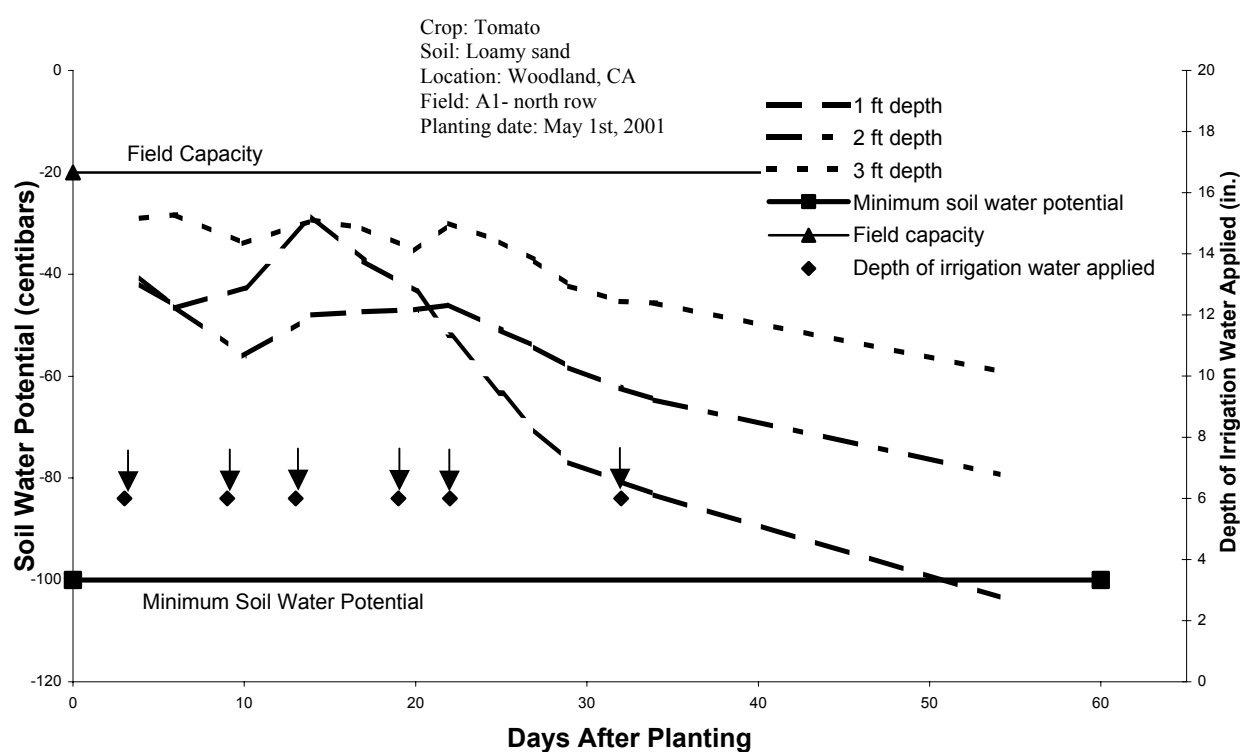
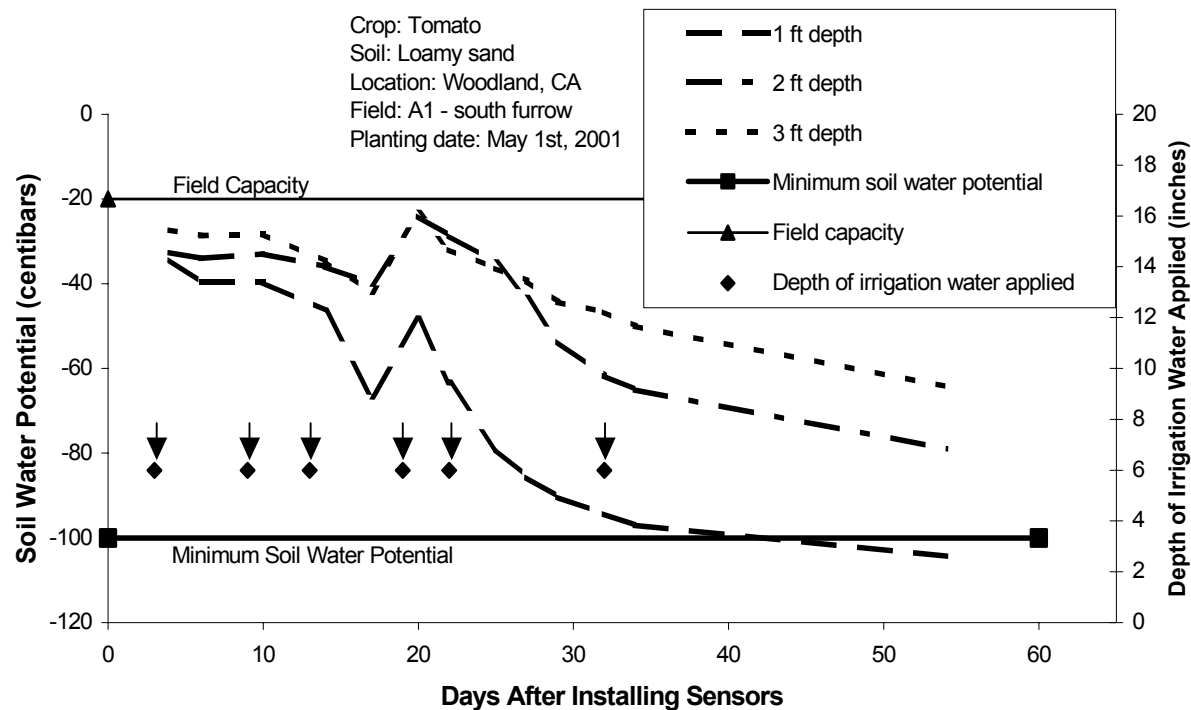
Figure 46: Soil water potential from sensors at three different depths in North row of Field A1.

Figure 47: Soil water potential from sensors at three different depths in South row of Field A1.

Results from this field are shown in Figures 46 and 47. Each figure contains the averaged sensor readings of the three stations along each subject row at the three designated depths. Irrigation events and average volume of irrigation water applied are indicated with arrows and points corresponding to the right side vertical axis. Irrigations until mid July lasted 48 hours during which every other furrow was irrigated. Later season irrigations were shorter (24 hrs long), but the sensors never registered a change in soil moisture from those latter irrigations. Soil tension was kept below 50 centibars for the most part during the season except towards the end when the farmer started preparing the field for harvest.

Apparent distribution nonuniformity was indicated by sensor readings that suggested that more water infiltrated at the furrow head than at the mid point and tail end locations.

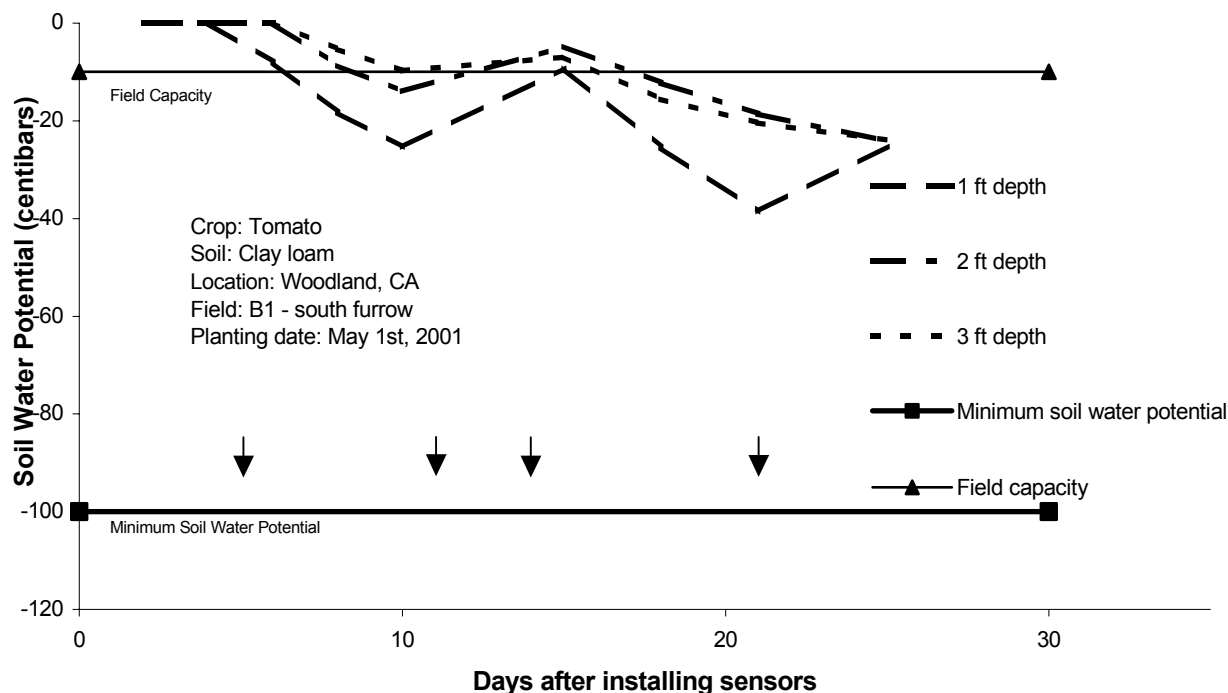
Figure 48: Soil water potential from sensors at three different depths in South row of Field B1

Figure 48 shows results from the southern row. These figures show soil tension in this furrow remained below 30 centibars for most of the season. Soil tension dropped to zero after each irrigation indicating soil reached the saturation point. Soil remained saturated for a few days after the irrigation in some cases. It was noted during sensor installation that soil was a very hard clay, which might explain this behavior.

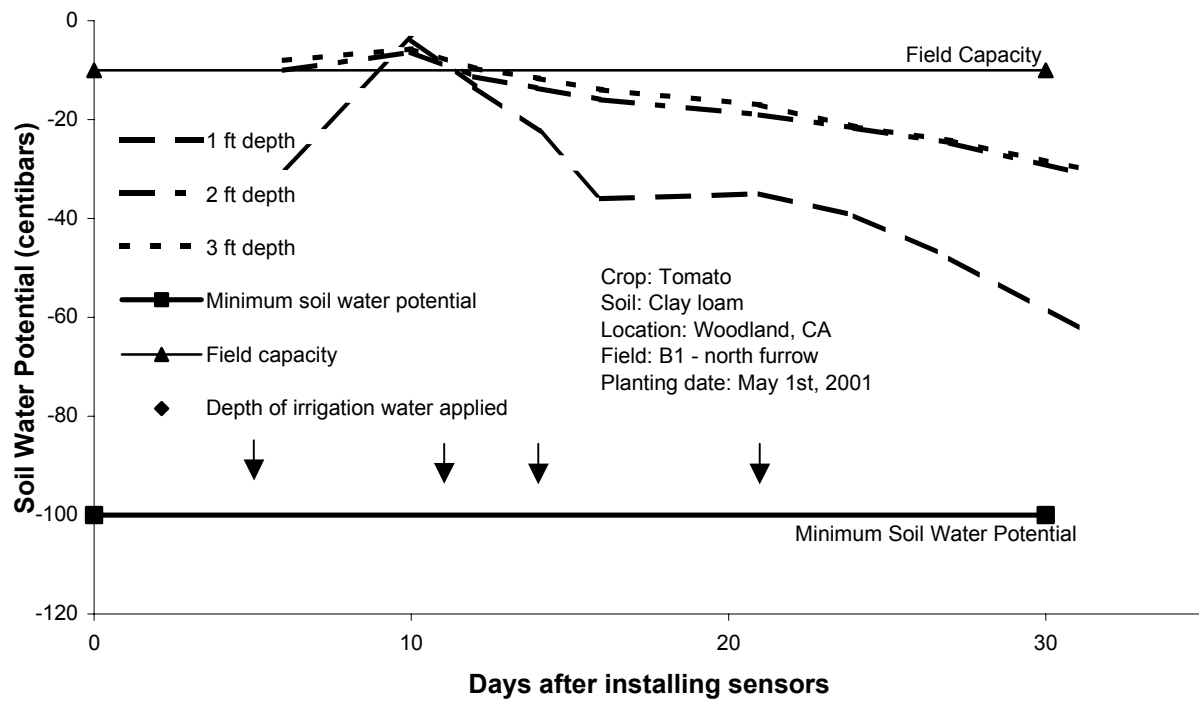
Figure 49: Soil water potential from sensors at three different depths in North row of Field B1

Figure 49 shows the results from the northern row. It should be noted that water didn't reach the 2-foot and 3-foot depth sensors, which explains the continuous increase of soil tension throughout the season. The two irrigations observed (not evaluated) on this row can be clearly identified from the 1-foot sensor readings. In addition, these irrigations are more apparent from the sensor reading in the field head locations and become less so in the downstream direction. This indicates a typical non-uniform irrigation pattern in which water infiltrates deeper near the furrow head than the furrow mid and tail end points because of greater opportunity time.

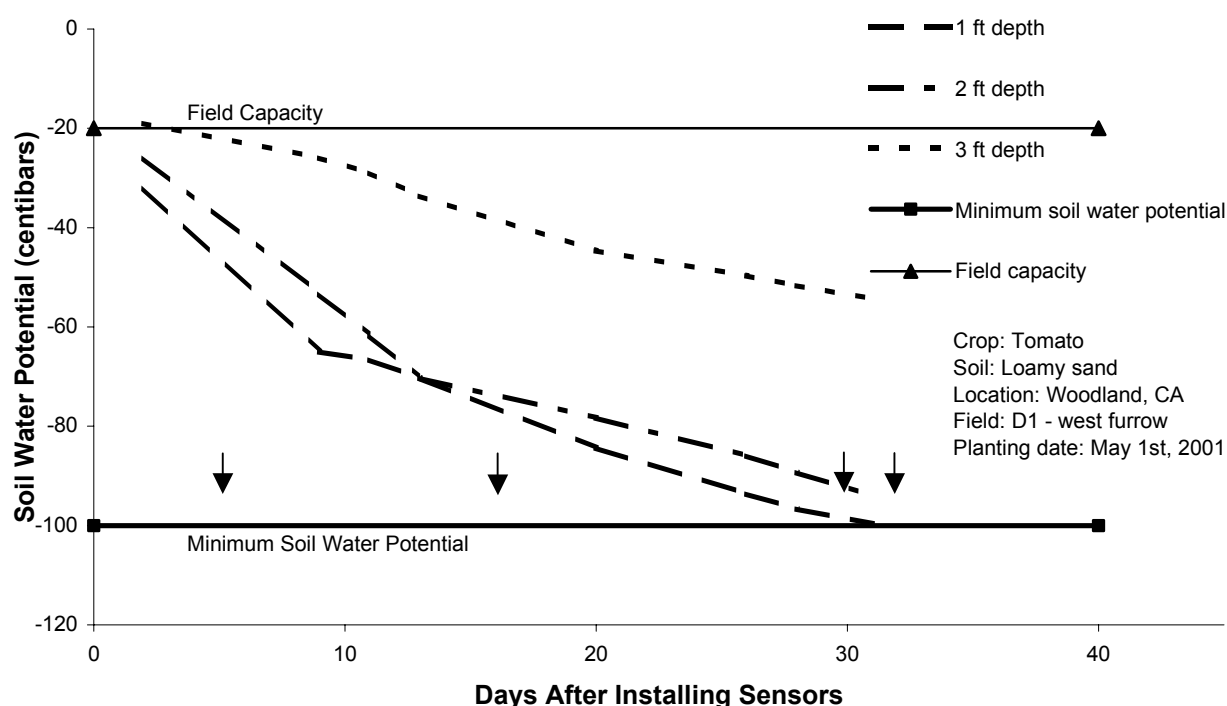
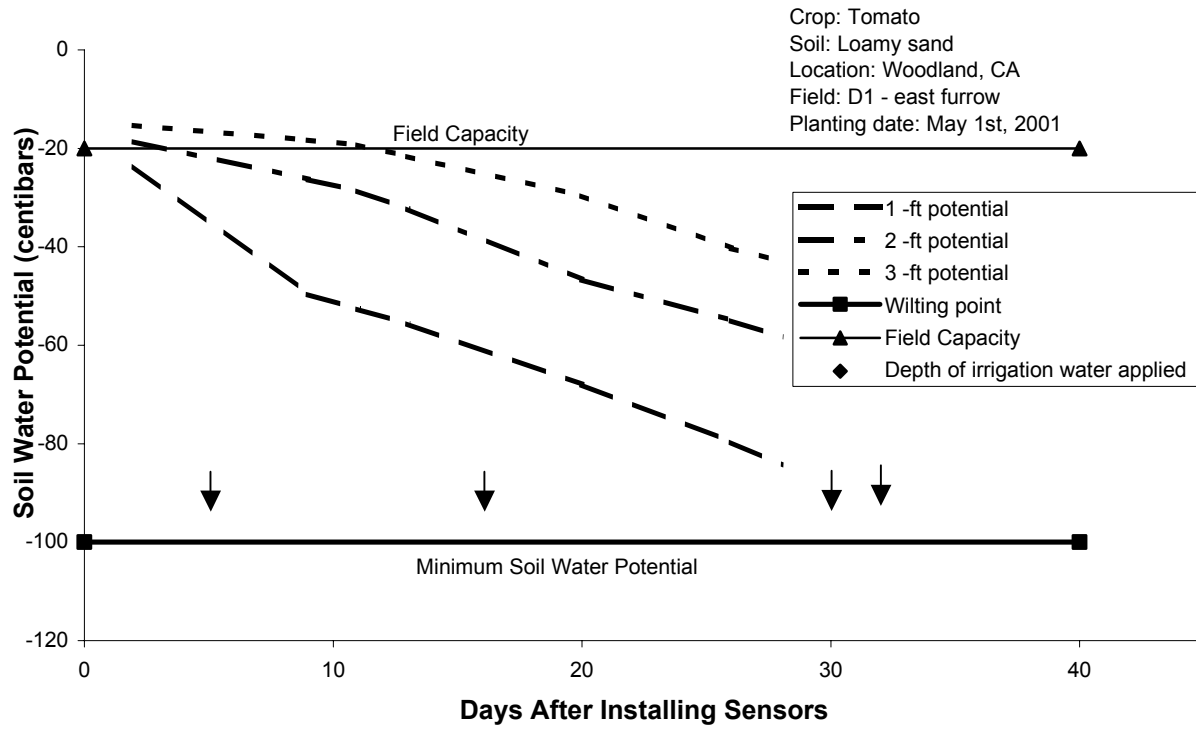
Figure 50: Soil water potential from sensors at three different depths in West row of Field D1

Figure 51: Soil water potential from sensors at three different depths in East row of Field D1

Results from this field are shown in Figures 50-51. Each figure charts sensor readings for one of the six stations. No irrigation events are apparent from these figures suggesting that applied water never reached the sensors at the bed middles throughout the season. The crop did not seem to suffer from water stress suggesting that roots were able to reach water (likely away from the bed middles). Close inspection of one station showed that soil moisture content within the top six inches of the soil decreased from the edge towards the center of the bed. Water not reaching the sensors could also be attributed to poor sensor installation. Another reason might be minimal lateral water movement across the soil. District personnel had a similar experience with a gypsum block study in this same field in 1997. Further study of this field is needed to determine the nature of water movement within the soil.

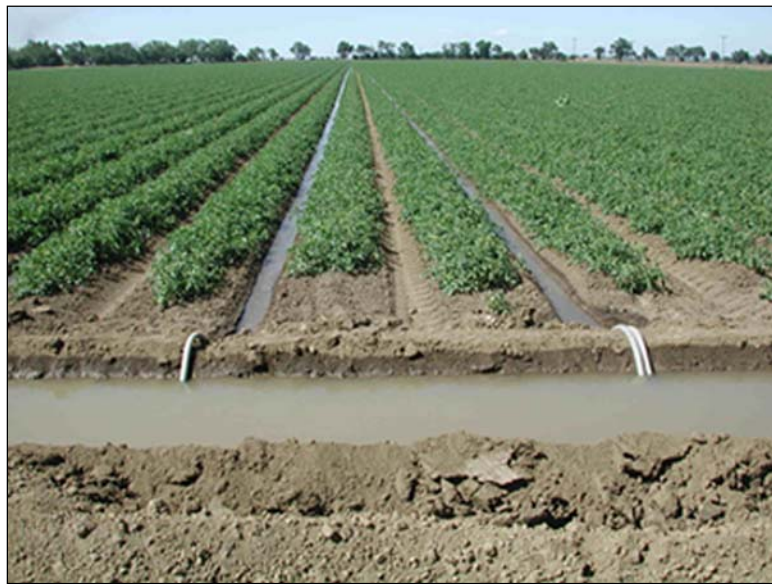
Figure 52: A typical siphon-fed, furrow-irrigated tomato field

We considered two means available for measuring flows in-furrow: 1) Flumes placed near the top and tail of furrows, and 2) Estimating flow through siphon tubes. For the first technique, the RCD staff used small RBC (Replogle Bos Clemmens) flumes to measure furrow flow rates during two irrigation evaluations this season but found them to be a fairly time-intensive technique with problems such sediment accumulation (which might have affected the accuracy of depth readings measured) and water seepage under the flumes (see Results section). As a result, the second technique, estimating flow rate through siphons using a volumetric approach, was the primary technique used to estimate inflow during the irrigation evaluations conducted in the pilot project. The volumetric approach was found to be simple, requiring only a stopwatch and a container of known volume, and took considerably less time per measurement and per furrow than flume installation and measurement. As with the latter, many furrows were required to generate a representative average for field inflow.

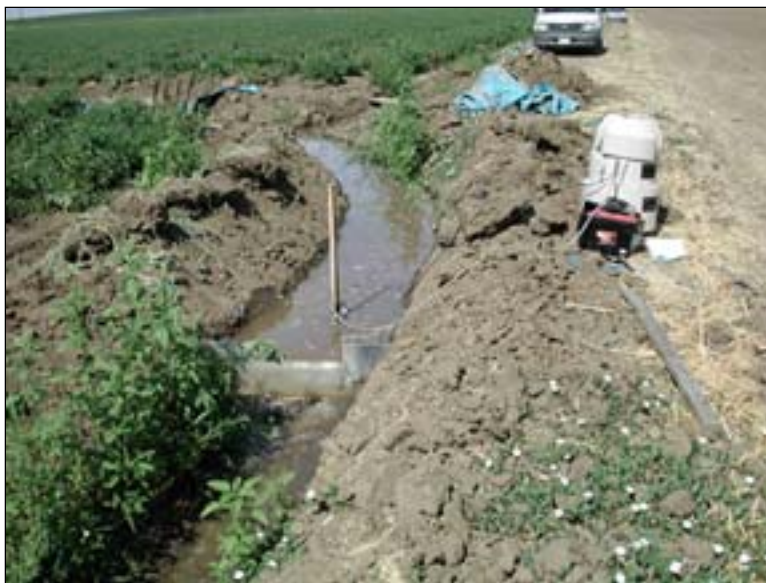
Figure 53: Runoff measurement using a rectangular notch weir, a pressure transducer, and the 900MAX PORTABLE SAMPLER by American Sigma

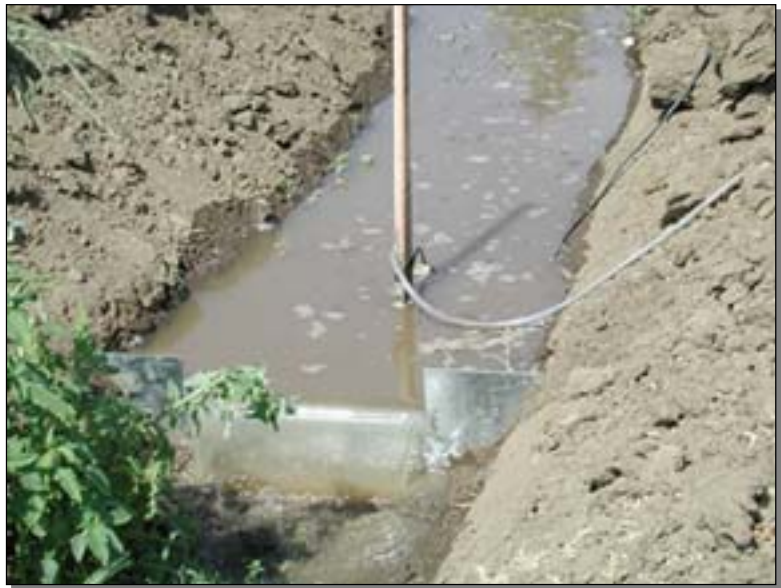
Figure 54: A closer look at the weir arrangement
